HA-1584

Frame Bank House
3119 Ady Road

INVENTORY FORM FOR STATE HISTORIC SITES SURVEY

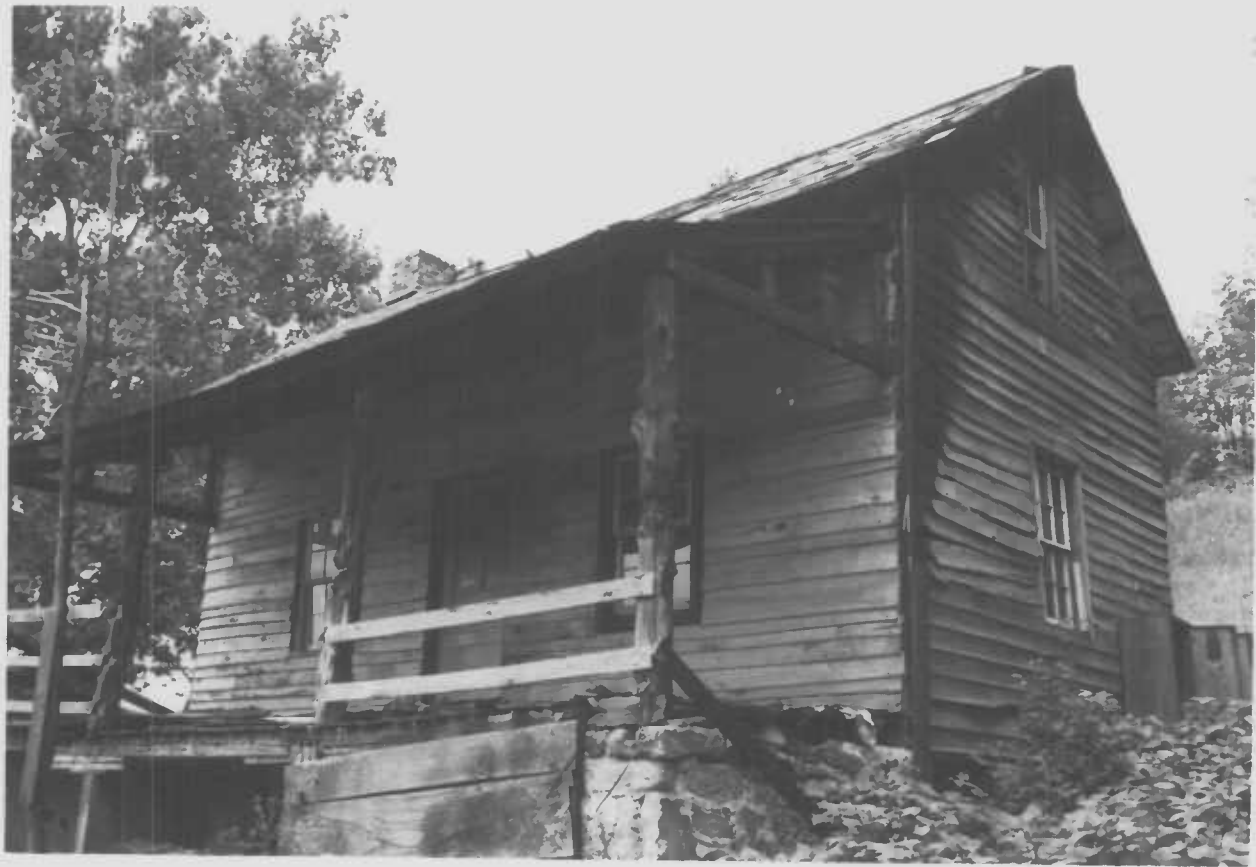
southeast elevation

This building was gutted by fire three weeks before recording.

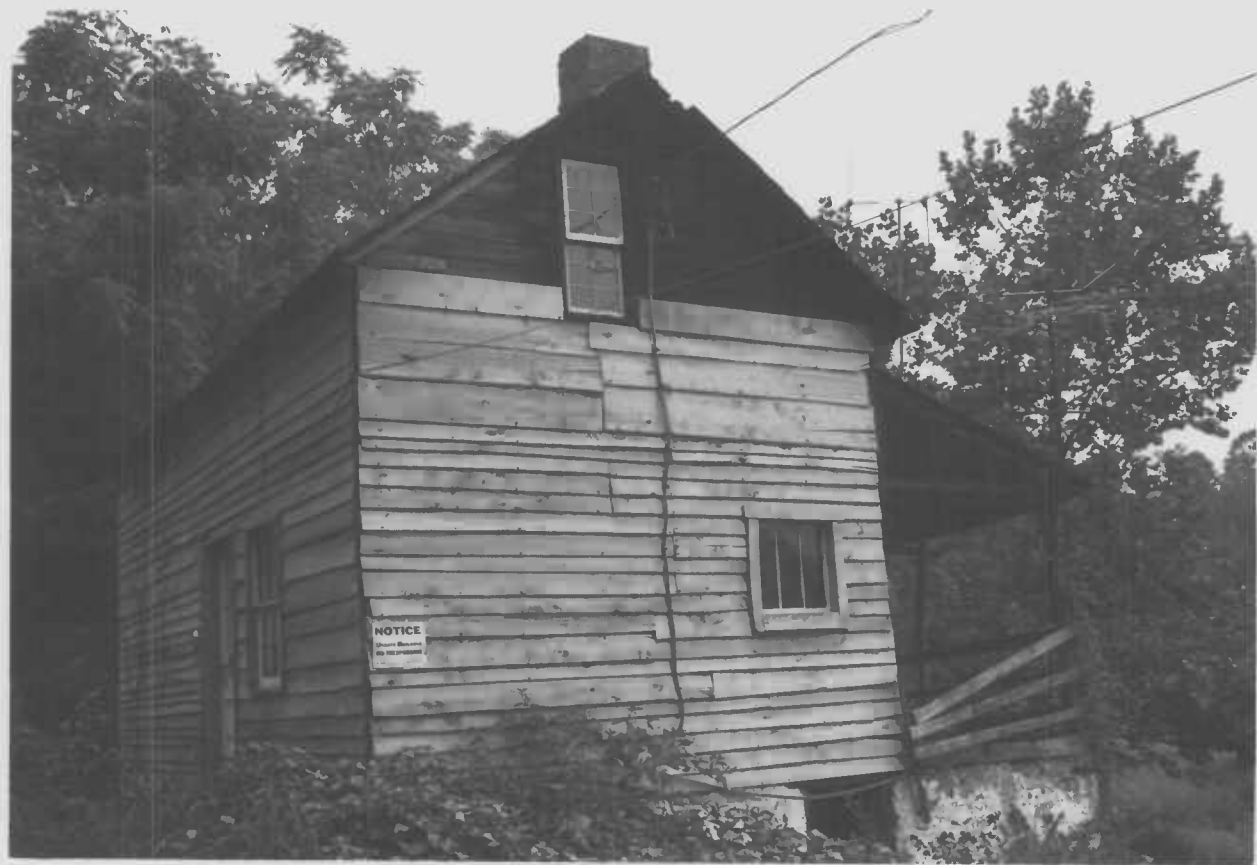
west elevation

An interior stove flue occupies the west gable-end and winder stairs for all three levels are in the north west corner of the building.

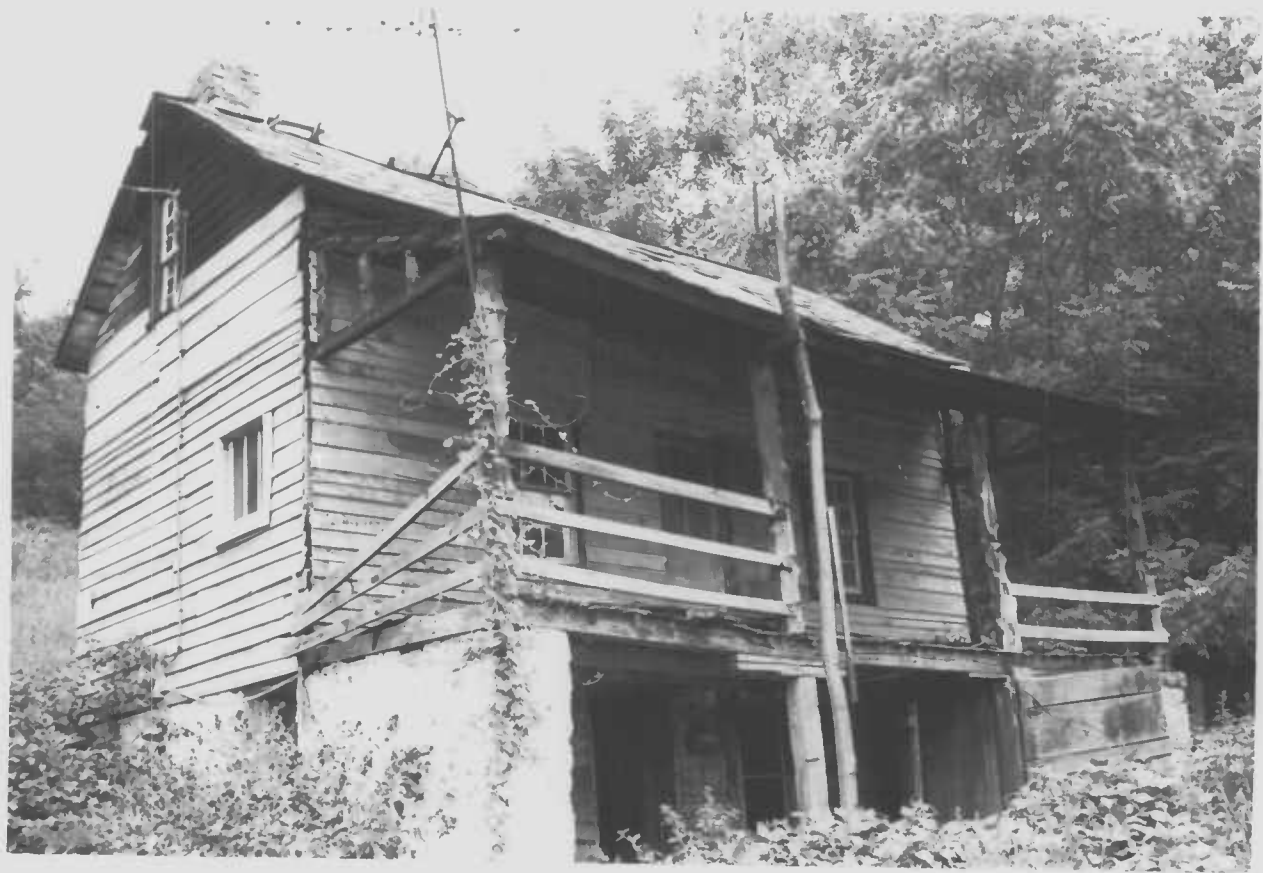
south elevation.

The south facade is perhaps the most interesting. The house is 14' deep, however, the stone end walls are a total length of 21'3" providing strong stone supports for the two-story gallery on this side. Transverse puncheons support the second story floor and unfinished treeposts support the shed roof. The south wall of the kitchen is not stone but frame, with whitewashed clapboards attached with cut nails.

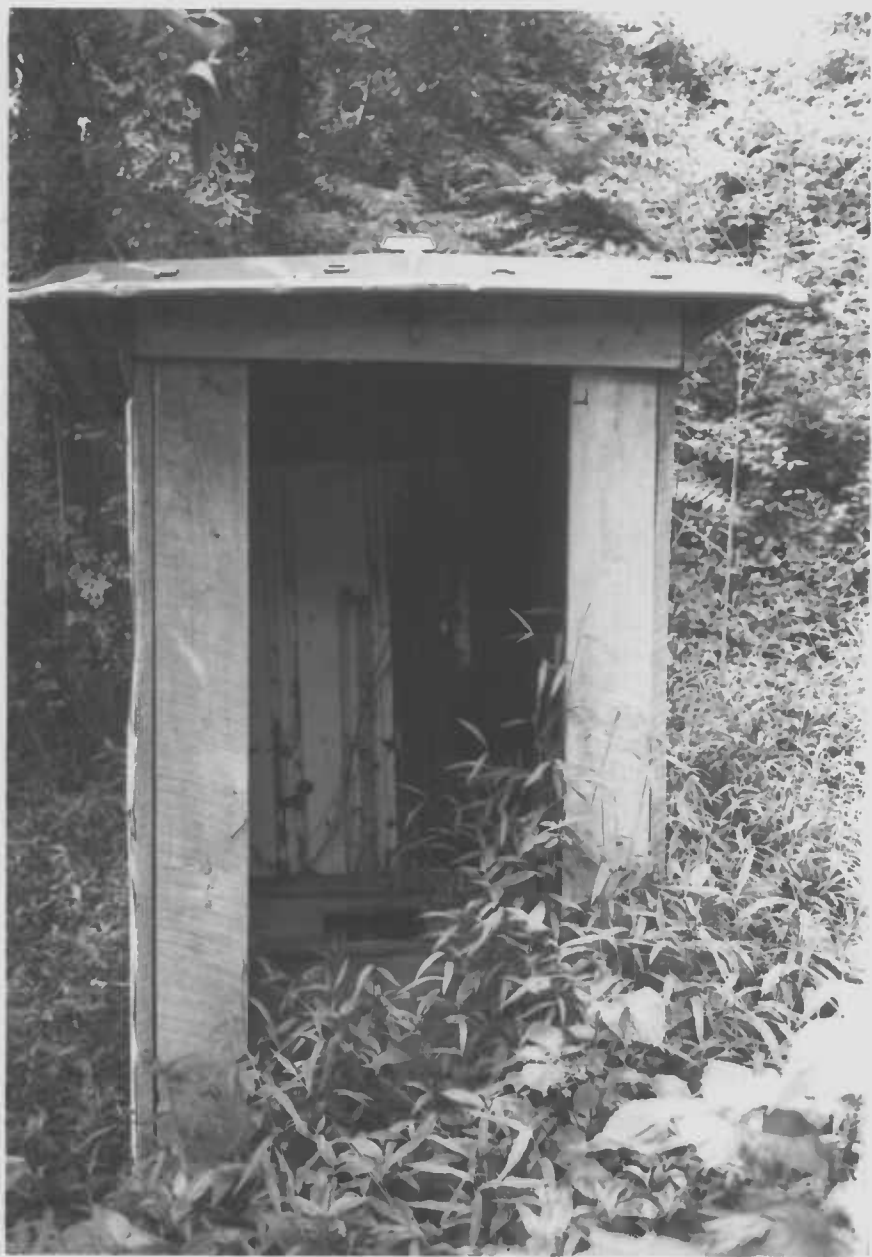
Privy- south elevation

Also on the site is a springhouse-dairy and a great number of sheds. The current privy is a most interesting construction consisting of corrugated sheet metal in the normal proportions for a one-holer. Its grand feature is a roof that is accomplished with the hood of a 1957 Ford. The down turn of the hood just above the radiator forms a streamlined cornice for the privy and the appropriately placed chrome letters of FORD announce the age of the materials and the paradox of their use.
